Case 262 : Narrative

Case Vehicle (A): 2000 Honda
Type: CR-V ES, AWD, 4-door SUV
Driver: 21-year-old female
CDC: 99-0000-0, 02-RDAW-3

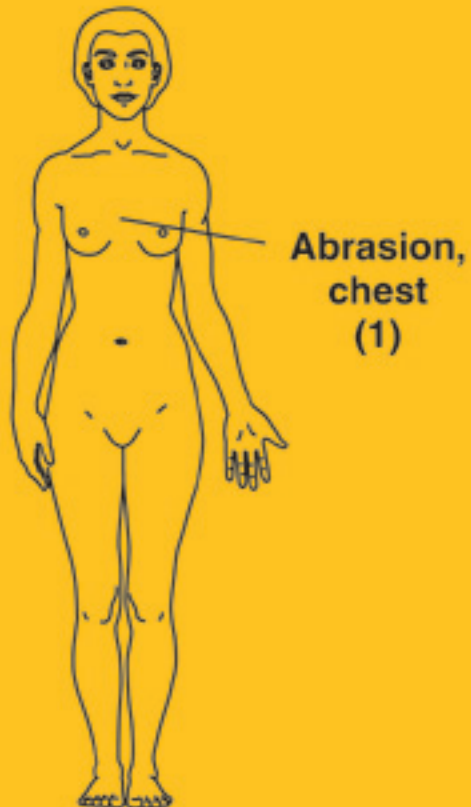
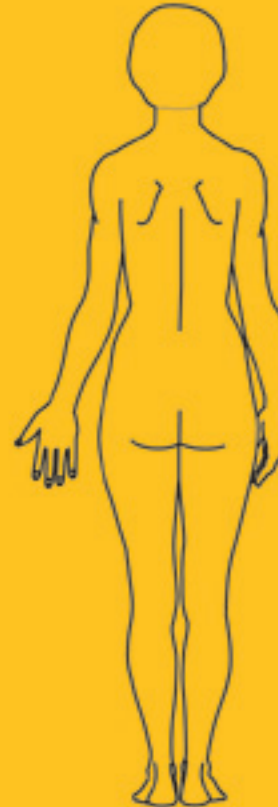
Occupant: Driver	Age: 21 years	Gender: Female		
Restraints: 3-point belt worn; frontal-impact airbag deployed	Stature: 165 cm (5 ft, 5 in)	Mass: 57 kg (125 lb)		
Injury Description	A.I.S.	Injury Source		
—	—	Definite	Probable	Possible
Abrasion, chest	1	—	Shoulder belt	Airbag
Maximum A.I.S. Level	1	—	—	—
Injury Severity Score	1	—	—	—

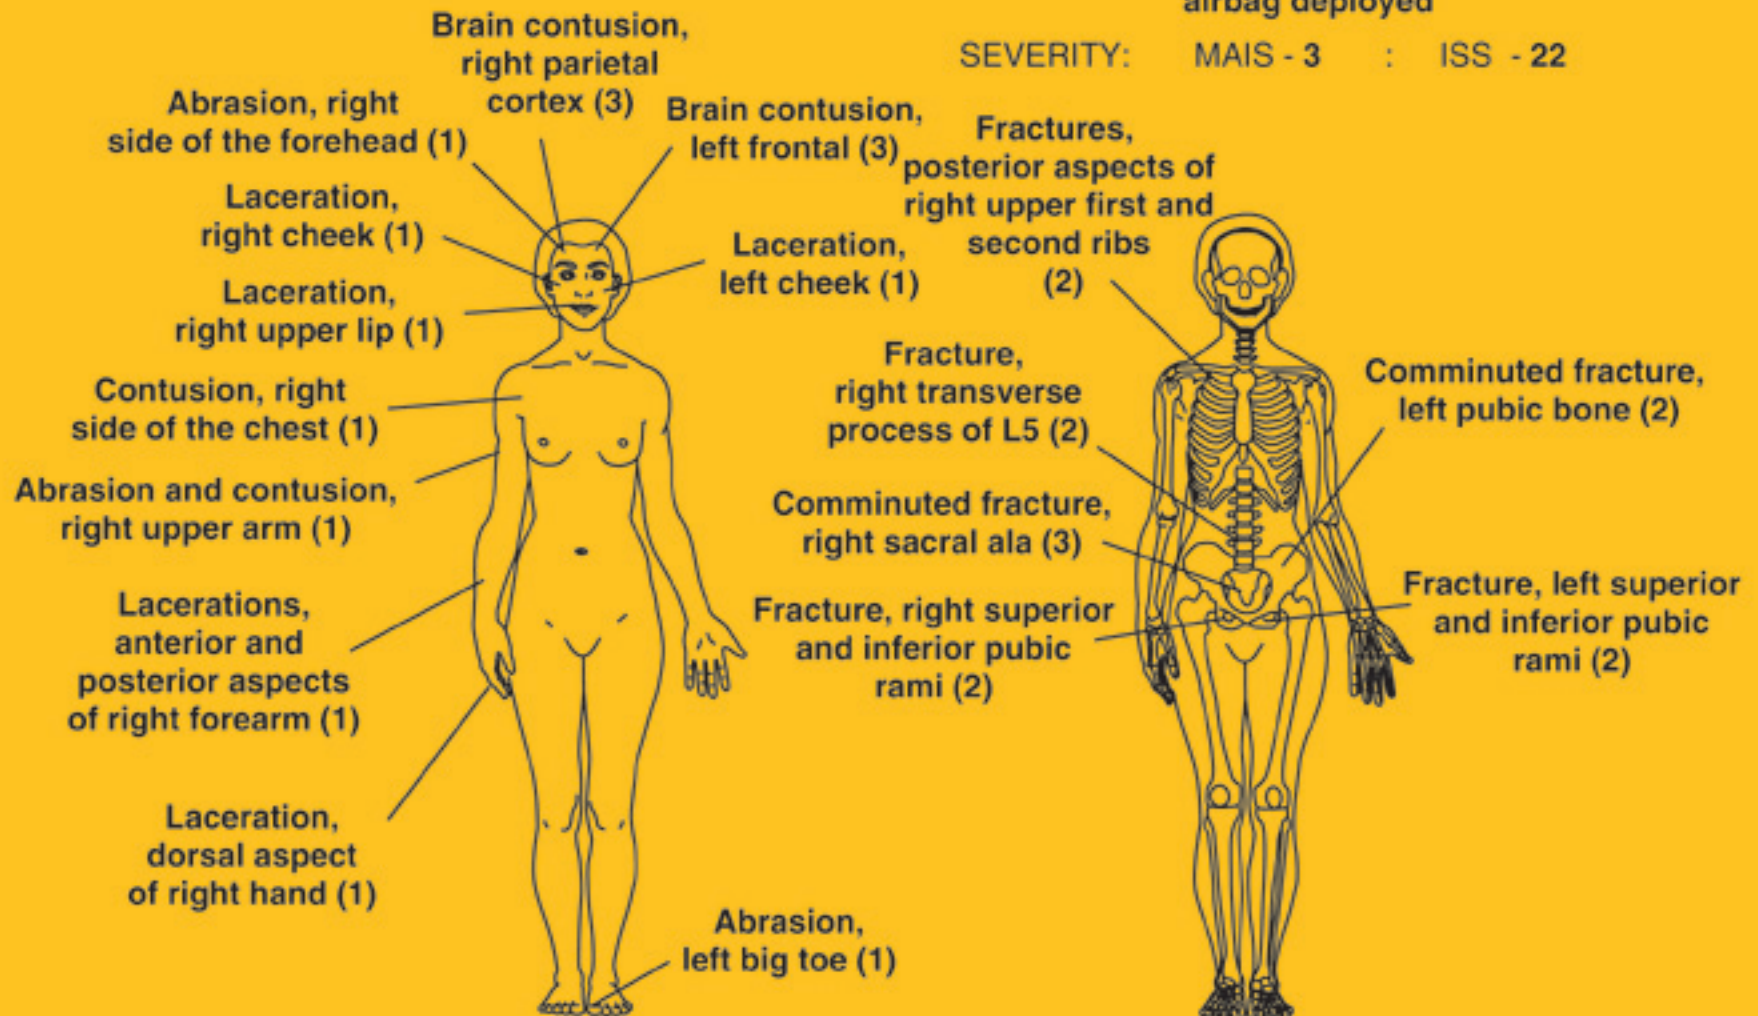
Occupant: Right-front	Age: 23 years	Gender: Female		
Restraints: 3-point belt <i>not</i> worn; frontal-impact airbag deployed	Stature: 160 cm (5 ft, 3 in)	Mass: 64 kg (142 lb)		
Injury Description	A.I.S.	Injury Source		
—	—	Definite	Probable	Possible
Brain contusion, right parietal cortex	3	—	Right-front door window, roof siderail, B-pillar	Ground
Brain contusion, left frontal	3	—	Right-front door window, roof siderail, B-pillar	Ground
Abrasion, right side of the forehead	1	—	Right-front door window, roof siderail, B-pillar	Ground
Lacerations, right and left cheeks, and right upper lip	1	—	Right-front door window, roof siderail, B-pillar	Ground
Contusion and abrasion, right upper arm	1	—	Right-front door interior	—

Fracture, posterior aspects of right upper ribs one and two	2	—	Right-front door interior	—
Contusion, right side of chest	1	—	Right-front door interior	—
Lacerations, anterior and posterior aspects of right forearm	1	—	Broken glass	—
Laceration, dorsal aspect of right hand	1	—	Right-front door interior	—
Fracture, right transverse process of L5	2	—	Right-front door interior	—
Comminuted fracture, left pubic bone	2	—	Right-front door interior	—
Comminuted fracture, right sacral ala	3	—	Right-front door interior	—
Fracture, right superior and inferior pubic rami	2	—	Right-front door interior	—
Fracture, left superior and inferior pubic rami	2	—	Right-front door interior	—
Abrasion, left big toe	1	—	Floor/toe pan	—
Maximum A.I.S. Level	3	—	—	—
Injury Severity Score	22	—	—	—

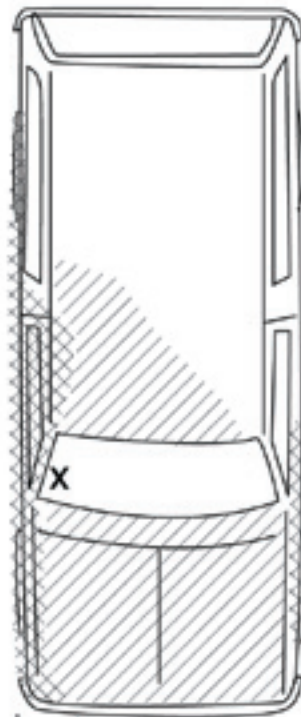
Damaged when towing vehicle out of ditch

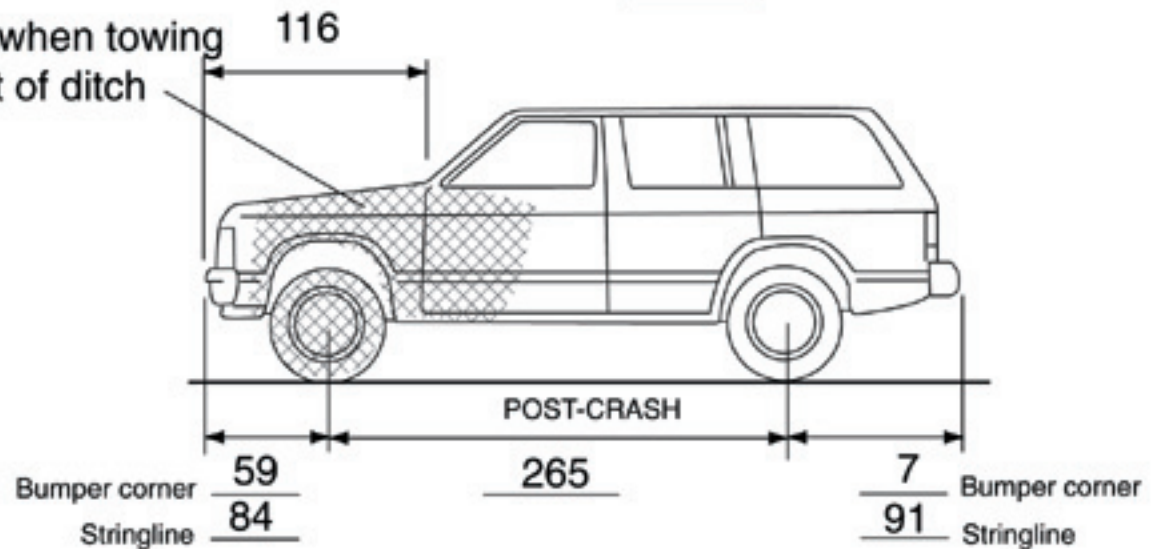
26

Max. crush to
right side at front
fender

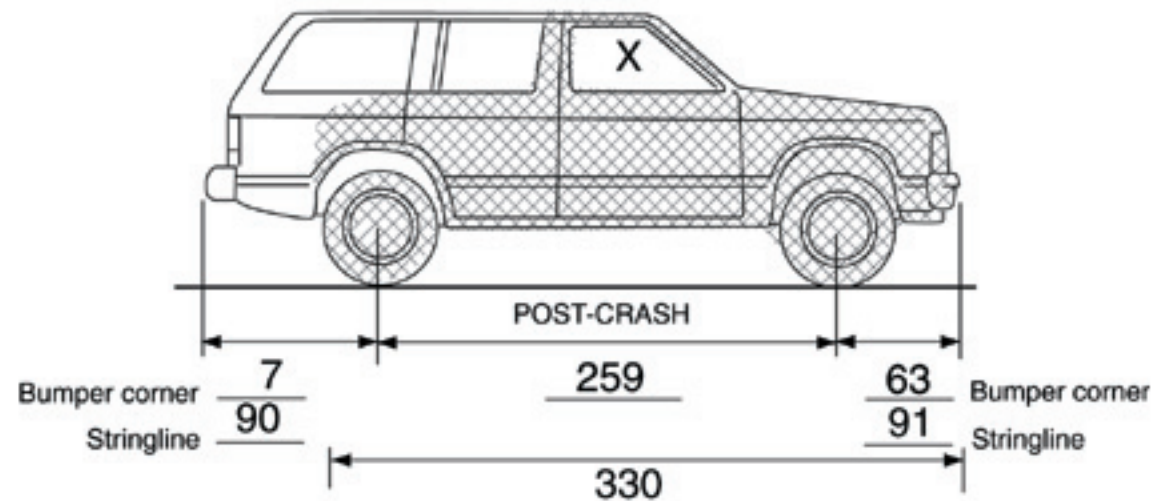
Length fo direct damage to right side

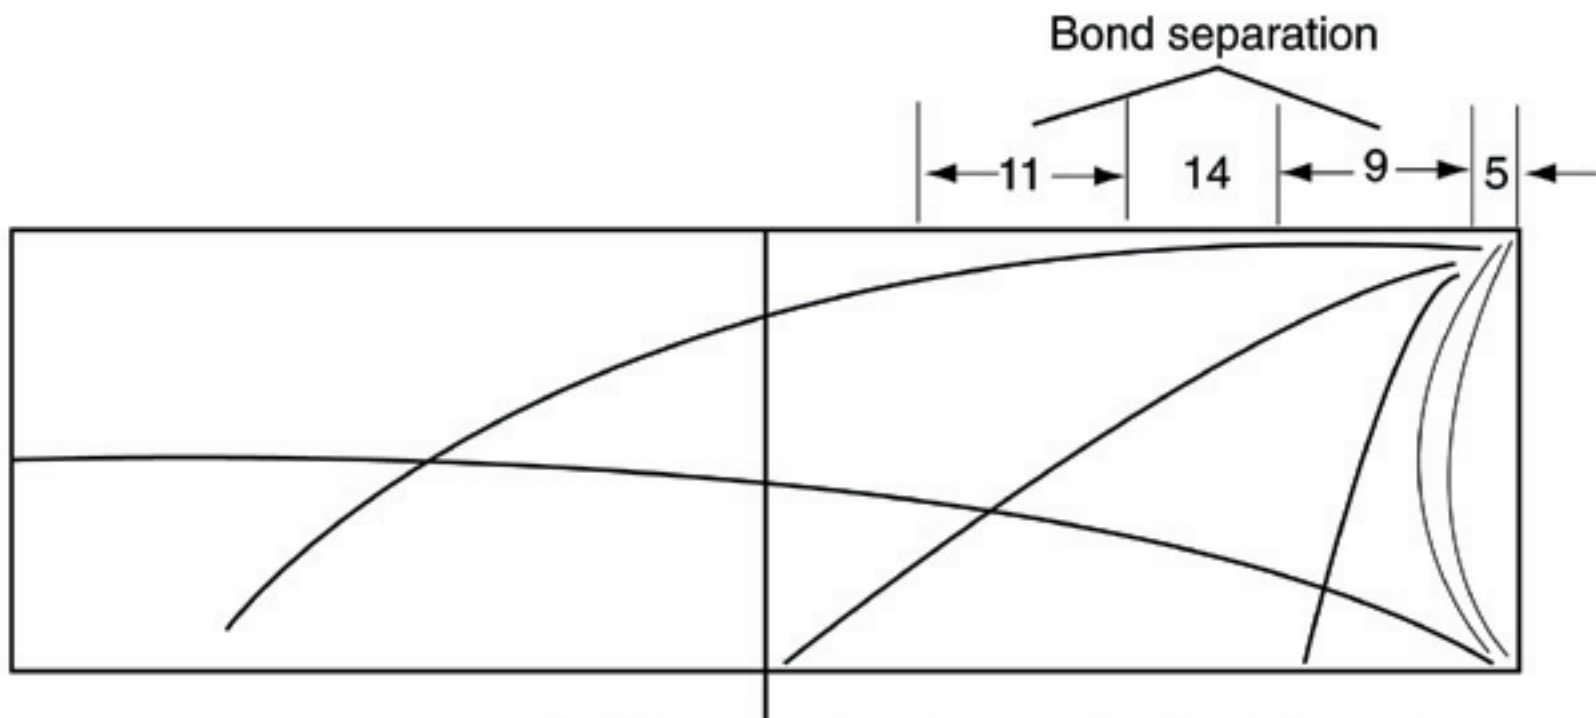
cracked due to roof and upper A-pillar deformation

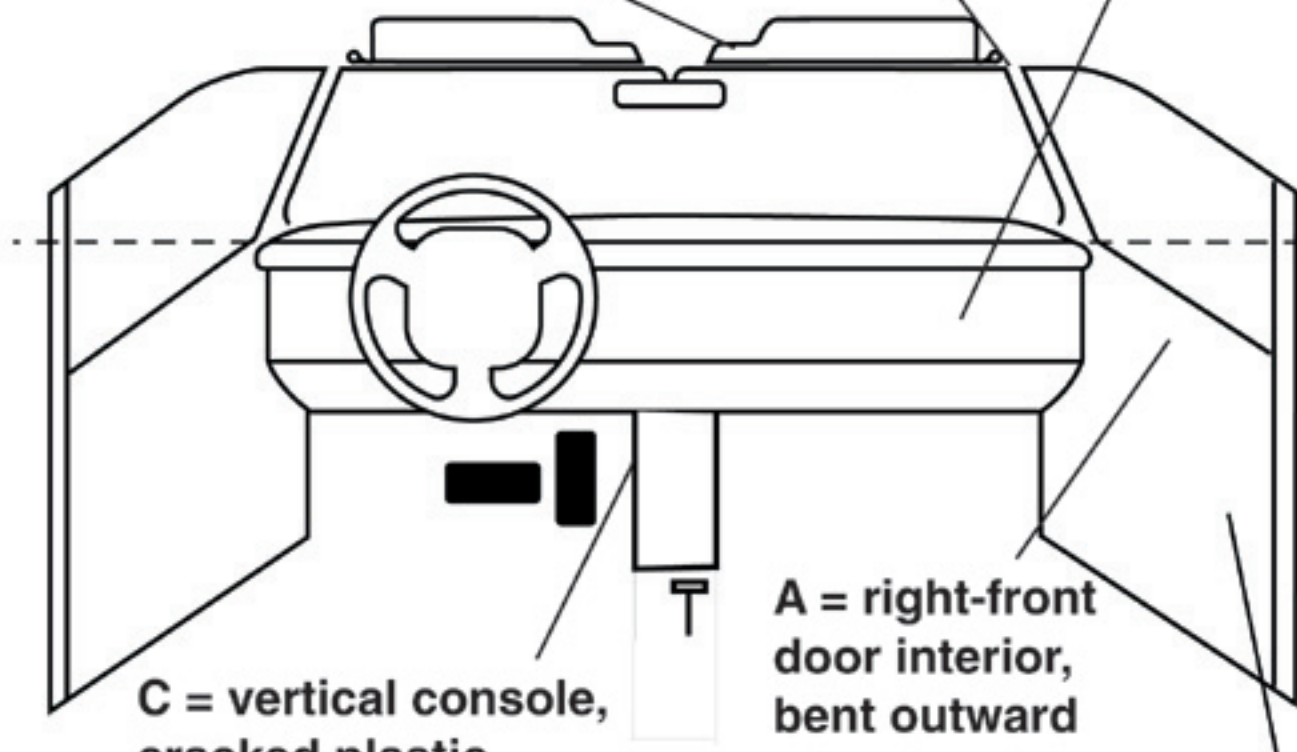
**D = right front sunvisor,
mirror broken, possible
scuffmark**

**E = right upper A-pillar,
possible scuffmark**

**F = airbag,
possible scuffmark**

**C = vertical console,
cracked plastic**

**A = right-front
door interior,
bent outward**

**B = right-front door
interior hardware,
broken plastic**

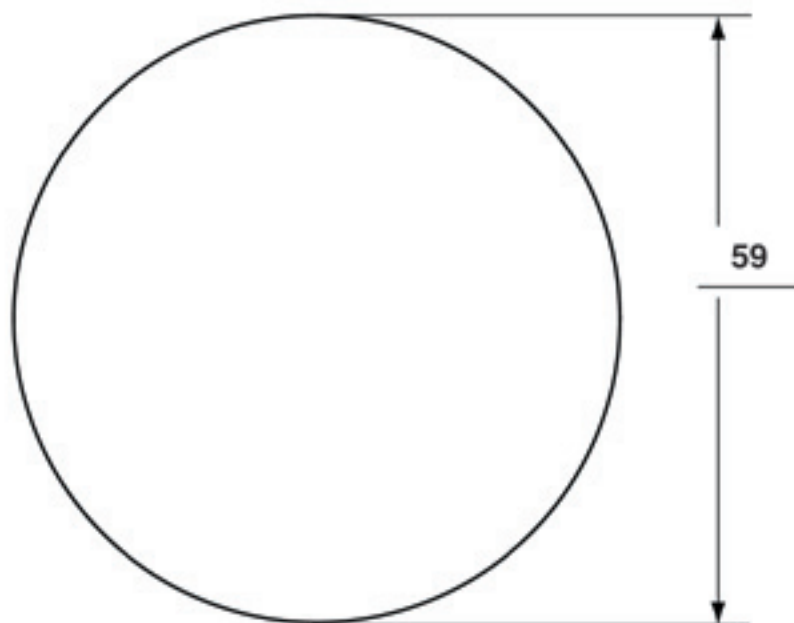
Driver Airbag

Vents: ☒ Y ☐ N
if yes, how many: 2
at 1 and 11 o'clock

Tethers: ☒ Y ☐ N
if yes, how many: 2
